Sealant Case Studies

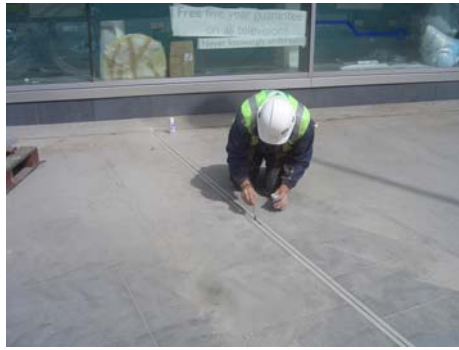
Delicate Floor Joints (vetter final ops 001)

The picture below shows an operative preparing a floor joint. This work was carried out at the **Paradise Project in Liverpool**. A major city centre re-development that **Miller Pattison** have been involved with for three years.

The pavement is natural stone granite. This means that material selection is critical, The sealant must not leach into the stone and stain it. This is a common failure when companies **do not** take the situation into consideration and use a cheap product for the work. The joint has had polyethylene joint backing inserted also you can see the edges have then been protected with masking tape.

The operative is applying **primer** to the joint faces. The tape prevents staining from the primer and the subsequent sealant application and tooling. The sealant is applied and tooled flush to the surface of the stone. The masking tape is then removed.

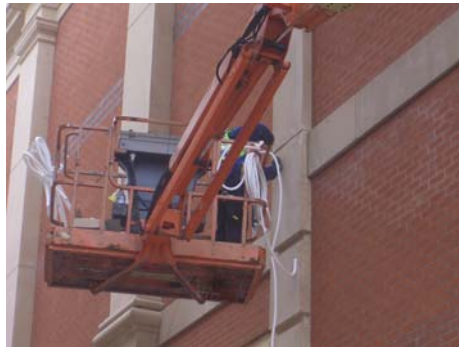
Trafford Centre - Manchester

The photo in this case study shows work being carried out from a hydraulic boom (or cherry picker). This work was carried out to the existing Trafford Centre.

The joint is first primed and the first lot of joint backing is inserted to the back of the joint. Then the first seal is applied. Following sufficient time, the second seal is applied over a second joint backer rod.

The silicone is tooled to a flat finish, slightly recessed from the face of the pre-cast concrete panels. All of this work was carried out from cherry pickers or scissor lifts. Due to programme delays, the work was ultimately completed on a night shift basis.

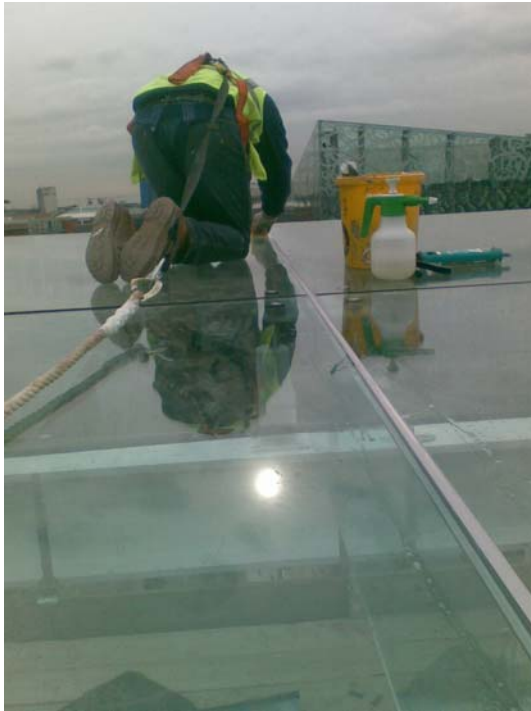
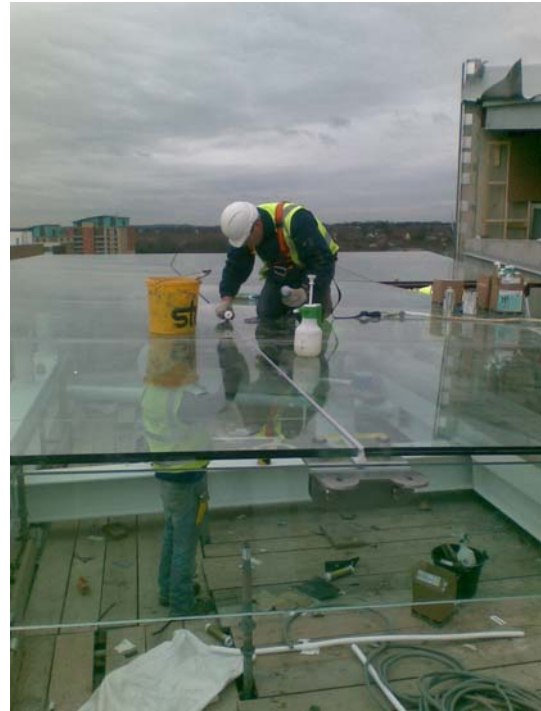
Sealant work on a building in Leicester city centre

Here are 2 pictures from a contract that we recently completed in **Leicester city centre**. There was a large volume of silicone application to glass facades and internal screens on this contract. As can be seen, we also sealed the roof of the atrium as well as the glass walls.

This car park building was nine stories high and the work was done from cherry pickers and a super large scissor lift!

Note the use of the harness and safety lanyard as well as gloves etc because we take health and safety very seriously. One photo shows a second operative working below, for this reason these particular roof joints had to be applied in one operation. After solvent cleaning, the sealant was applied to the full depth of the joint from above. The joint was then tooled flush by both operatives at the same time. Note the quality of finish on the grey silicone that has been applied and tooled.

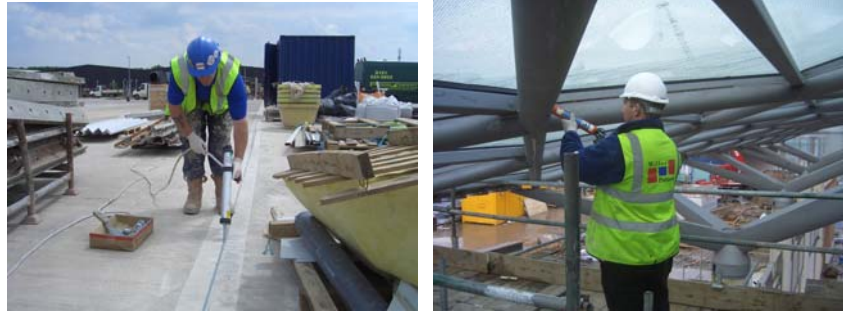
Royal Mail Hub – East Midlands Airport

The first shot shows one of our operatives using an air powered gun for the application of floor grade sealant to the **new Royal Mail hub** contract at **East Midlands airport**.

We also had to carry out concrete repair operations to this contract using low viscosity injection epoxy resin to cracks in the floor slab and epoxy mortar to make good defective concrete.

The second shot shows one of our operatives sealing the steel structure under a glass canopy at the **Paradise Project in Liverpool**.

This exercise was to seal large unsightly gaps and prevent birds from nesting in the voids between the steel sections.

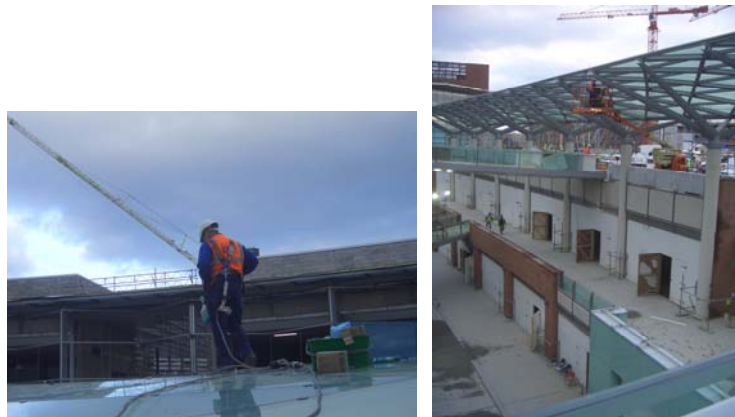
Eiffel at the Paradise Project in Liverpool

We had to organise a man-safe system from a specialist company. This was for the operatives to attach their harnesses to, which permitted movement around the canopy yet provided a safe working environment.

As each section was completed, we had to move the man-safe system along the canopy steel. One photo shows an operative in a cherry picker that was on the top deck of the building. He is under the canopy and moving into position to re-fix the safety lines further along the steel structure.

We also had to remove all the fixing plates, one at a time, seal the joint below and then re-fix the plates

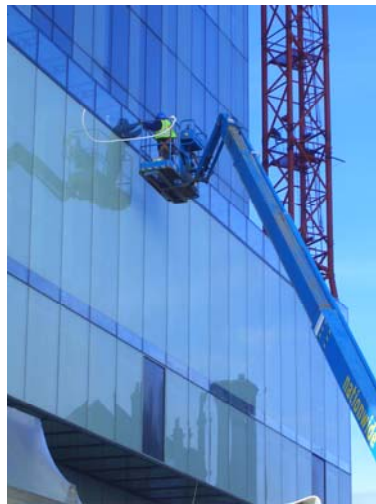
Hilton Hotel - Manchester

This first photo shows one of our operatives applying top grade structural silicone to the external glass roof and wall at the recently completed Manchester Hilton hotel. The section that he is working on is actually the swimming pool!

This feature actually extends out from the main structure of the building. Miller Pattison sealed all the glass roof *and* surrounding glass wall joints throughout the whole building.

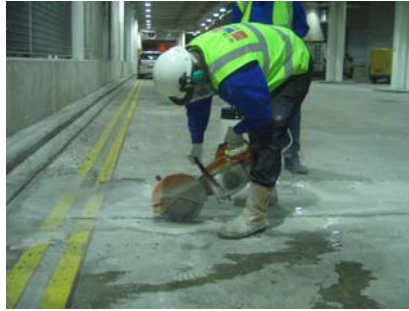
Warrington Golden Square Shopping Centre

Miller Pattison operatives prepare concrete floor joints prior to sealing with fuel proof two part epoxy polyurethane sealant.

This work was done on a night shift basis, as the Warrington Golden Square shopping centre was then open and the work had not been done by the concrete contractor. The work entailed forming many of the joints and repairing the concrete before sealing could take place. Note the full use of PPE and the independent water supply to eliminate the dust generated by the Still saw.

The material was chosen also due to the quick cure rate, so that the service road use was not impeded in any way.
